Limited Visual Dam Safety Inspection Summary Report

MA-143

Kailili Reservoir

May 2006

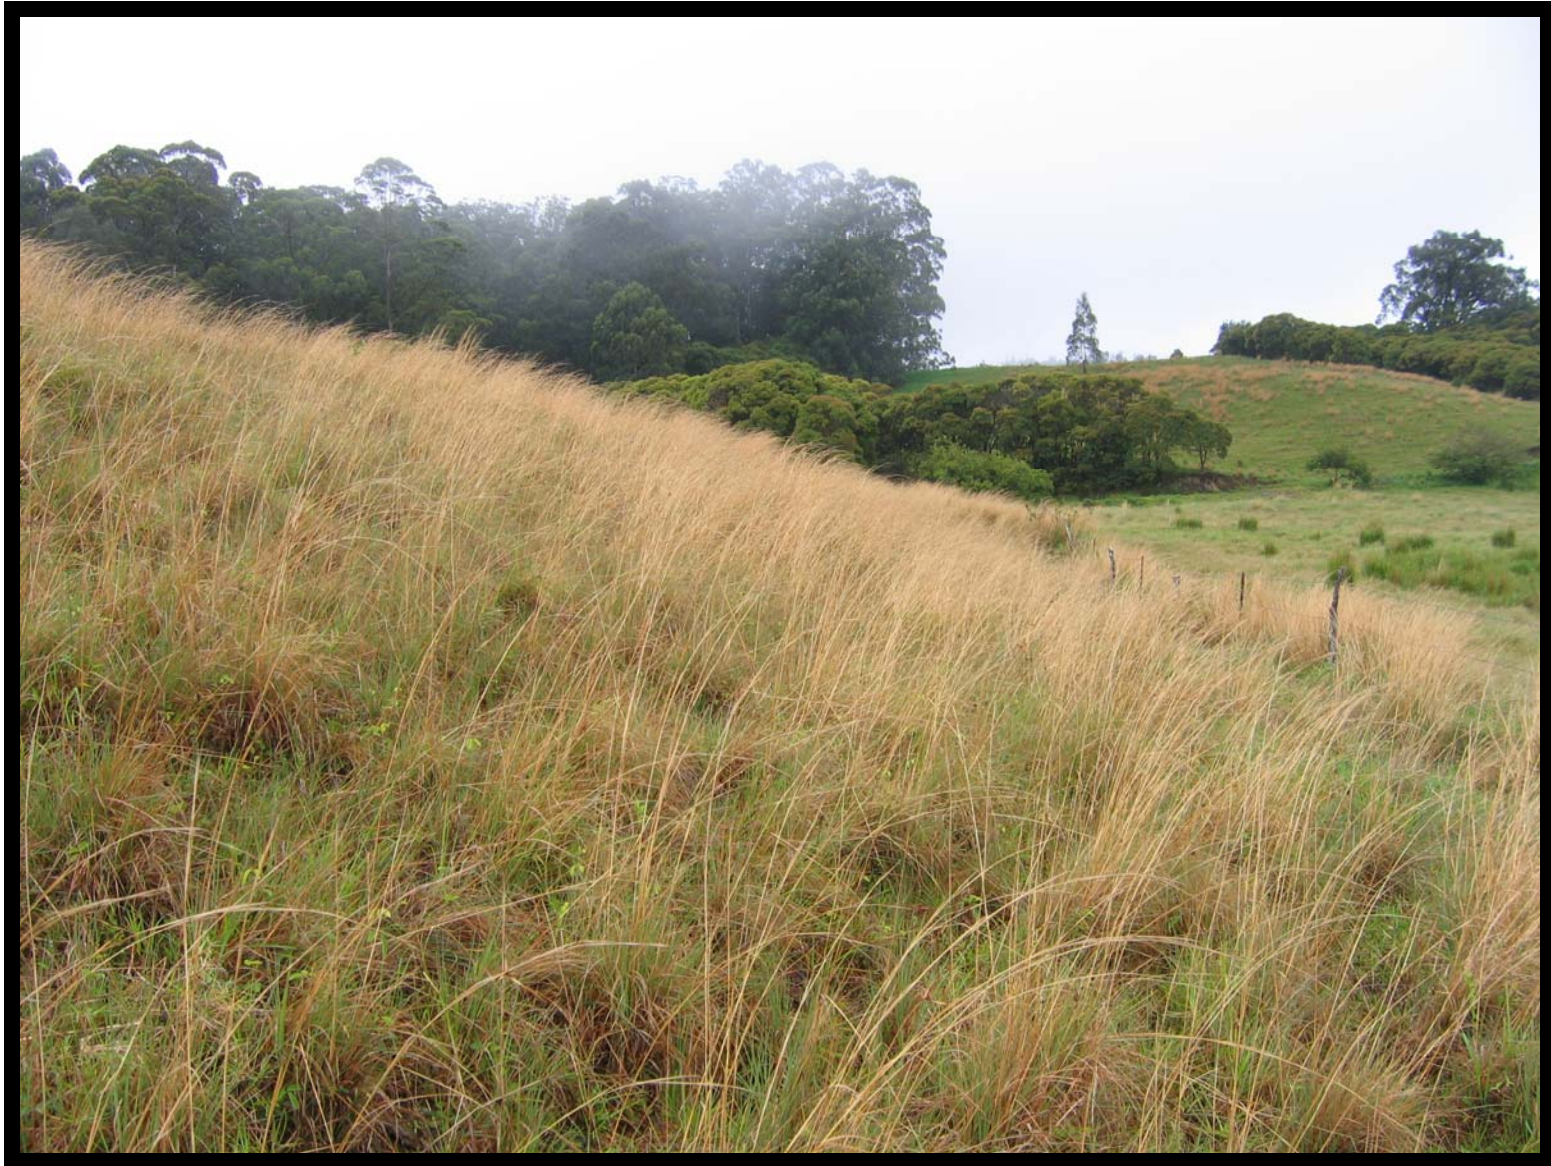
143 Downstream slope

The downstream slope was about 2.5H to 1V. The downstream slope was not entirely visible due to tall grass. There was access to the downstream slope by a walking. There was no slope protection observed on the downstream slope. Erosion was not observed on the downstream slope; however the slope was not entirely visible. Sinkholes were not observed on the downstream slope; however the slope was not entirely visible. Seepage was not observed on the downstream toe; however the slope was not entirely visible.

- a. The downstream slope appeared to be in fair to poor condition and requires corrective action.
- b. The down stream slope was not visible due to high grass and bush vegetation. Clear high vegetation and maintain low to enable easy visual inspection.

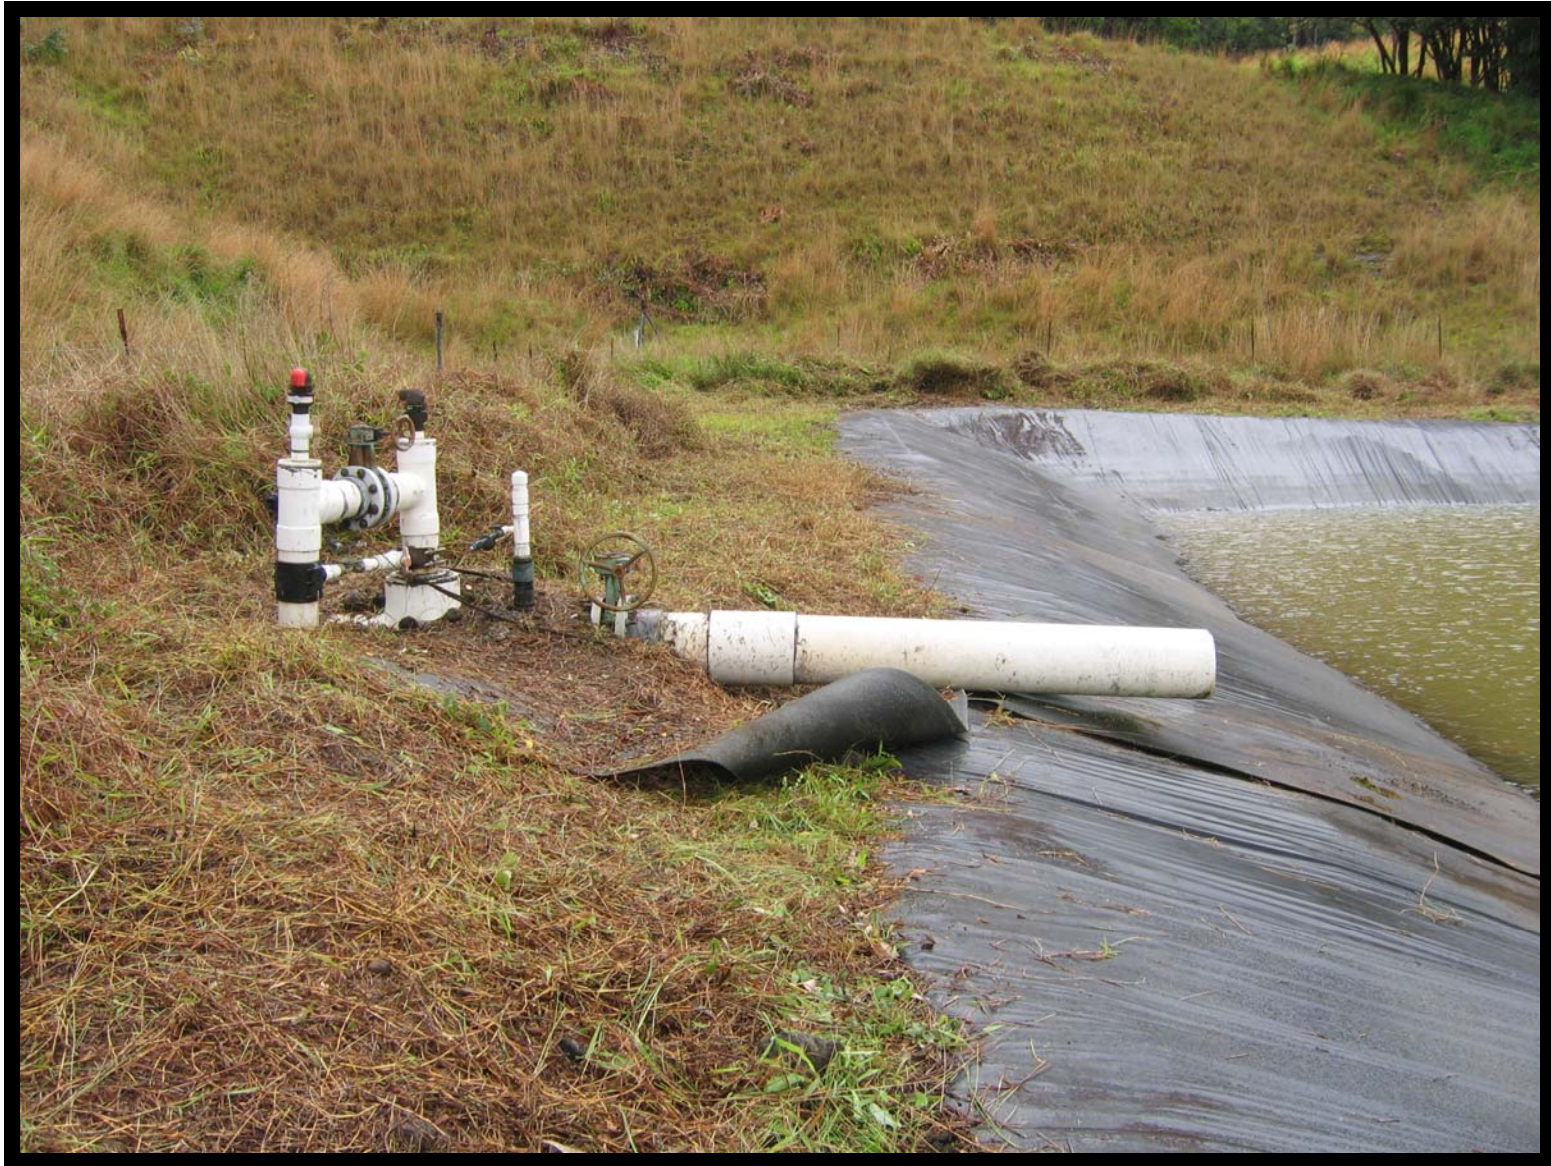
143 Inlet pipe

- a. The intake works were not tested.
- b. The intake works appeared to be in satisfactory condition, no corrective actions are required at this time.

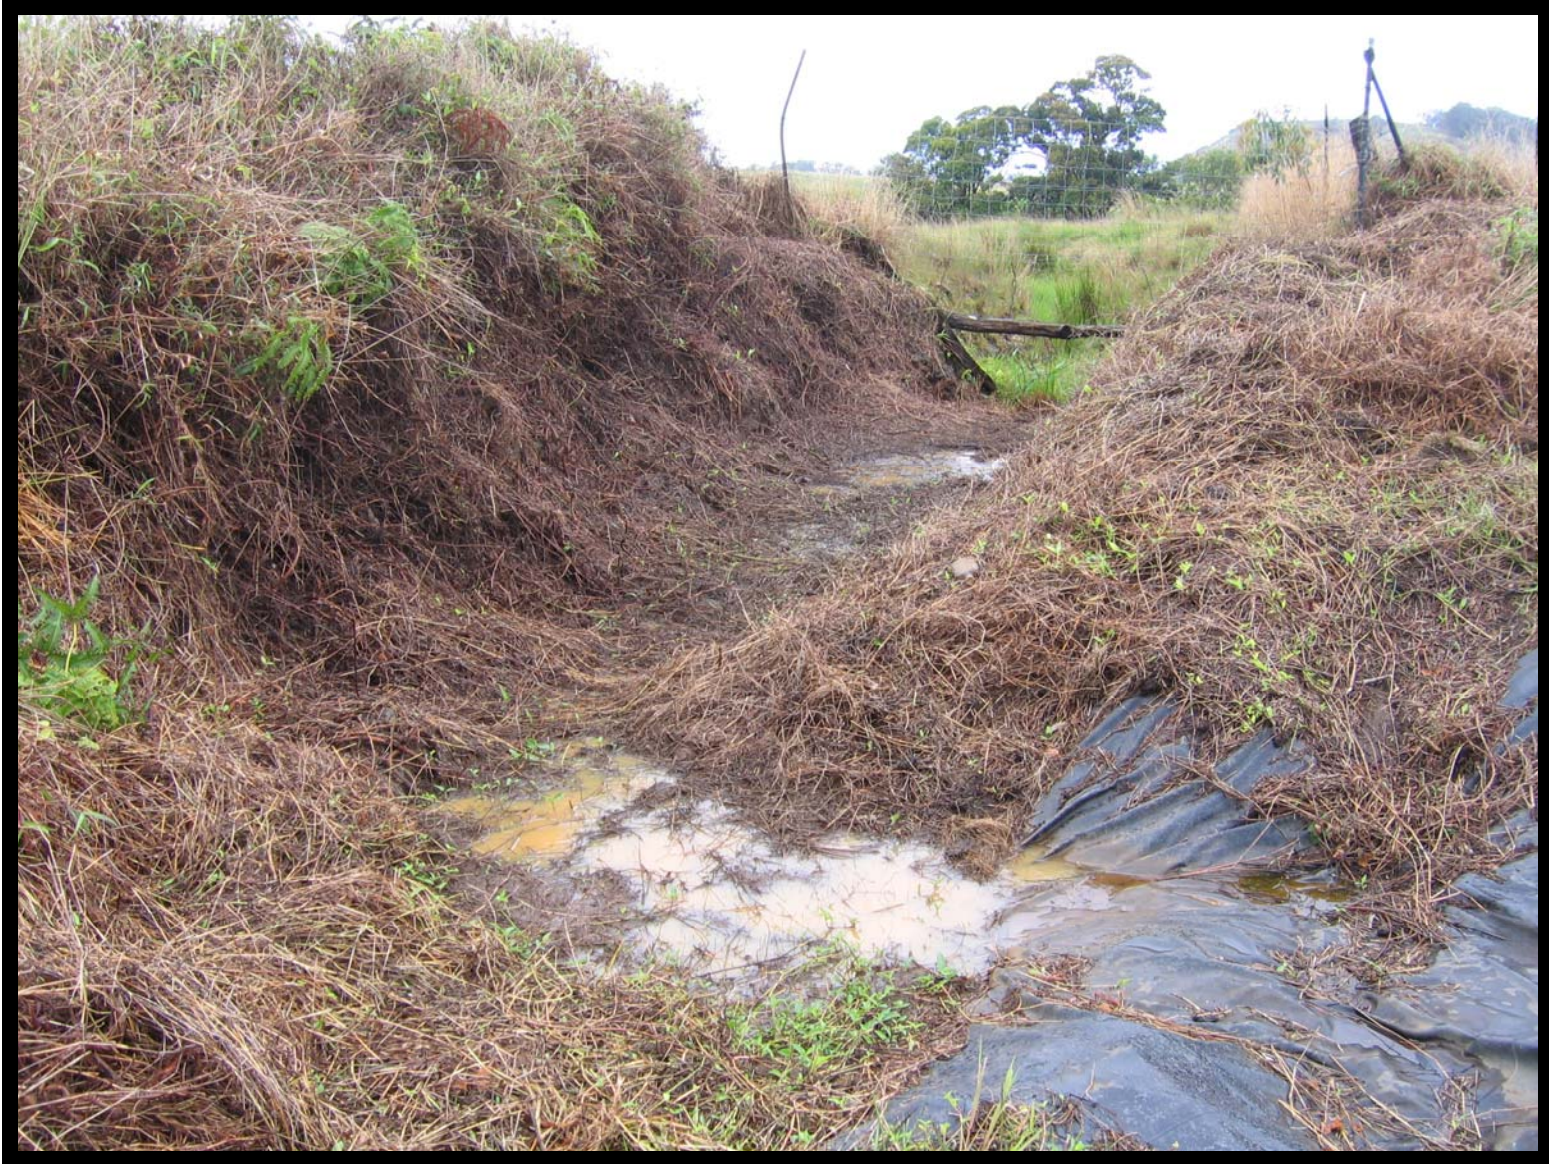
143 Outlet channel

- a. The downstream channel was not inspected.
- b. The downstream channel appeared to be in fair to poor condition and requires corrective action.

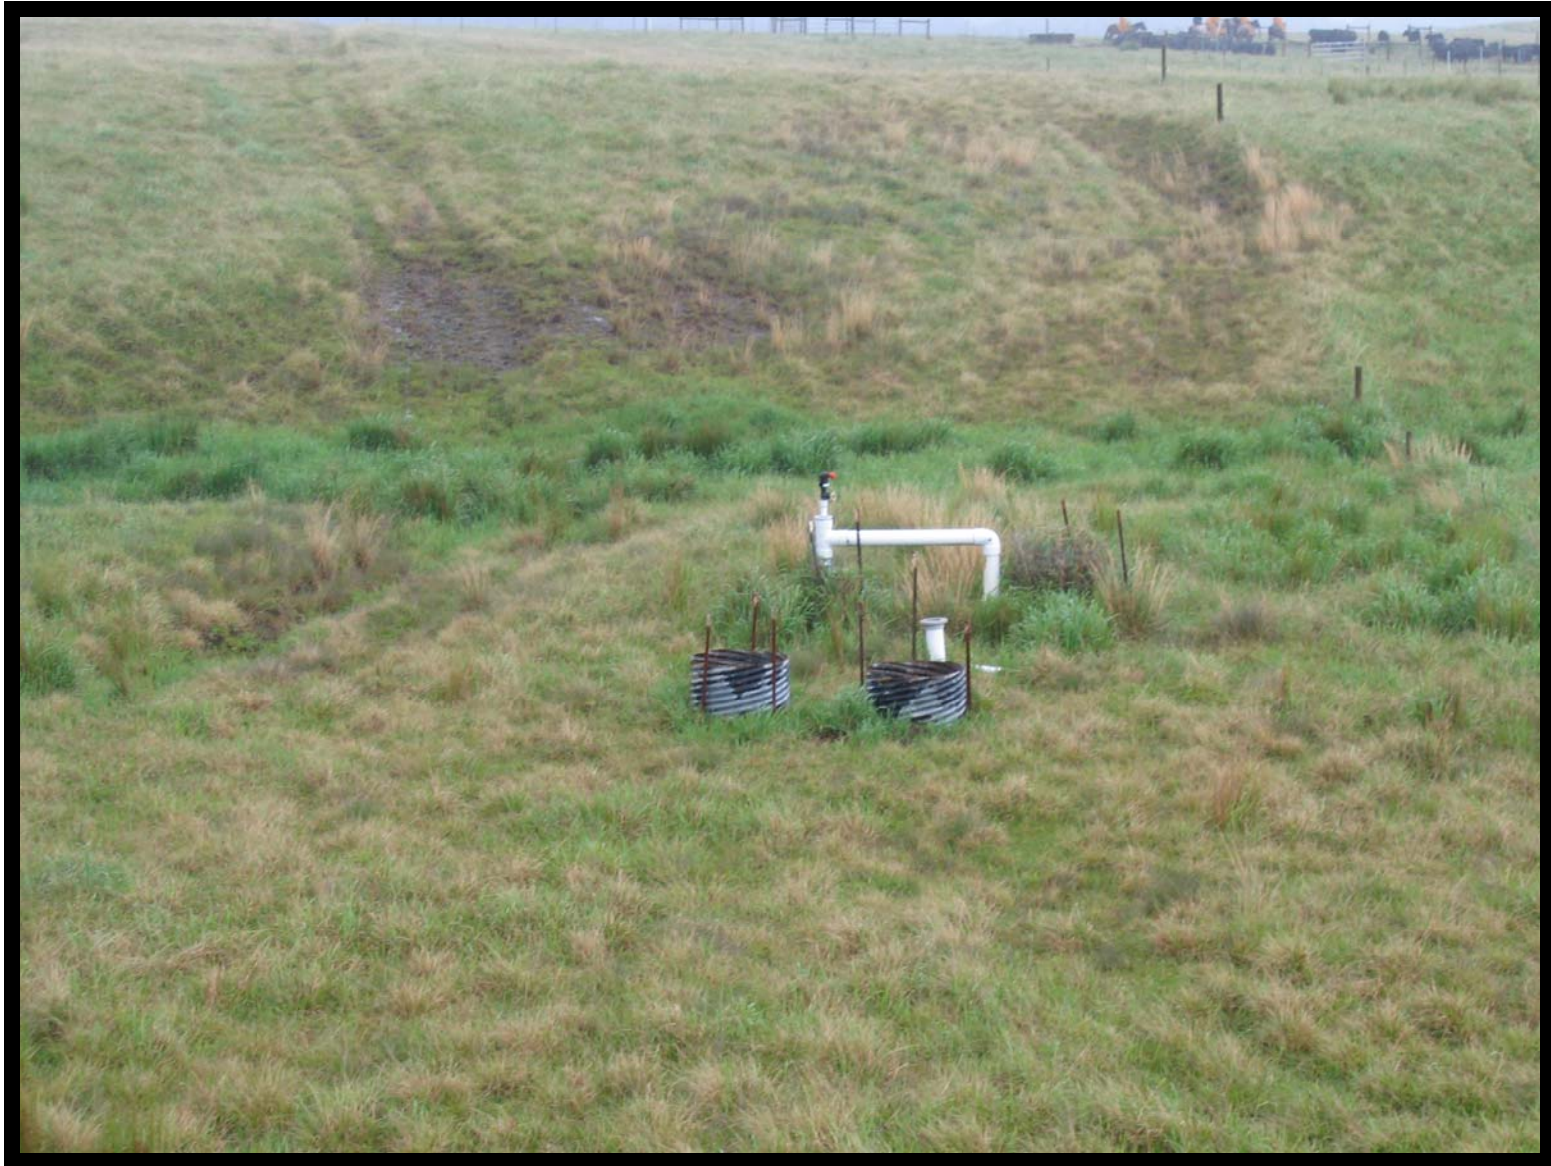
143 Outlet works

The outlet consisted of a submerged 8-inch diameter PVC pipe but was not inspected in detail, not tested. The outlet works was controlled via a valve on the downstream side of the dam. Seepage was not observed flowing near the exit of the outlet works from the dam.

- a. The outlet works were not tested.
- b. The outlet works appeared to be in satisfactory condition, no corrective actions are required at this time.

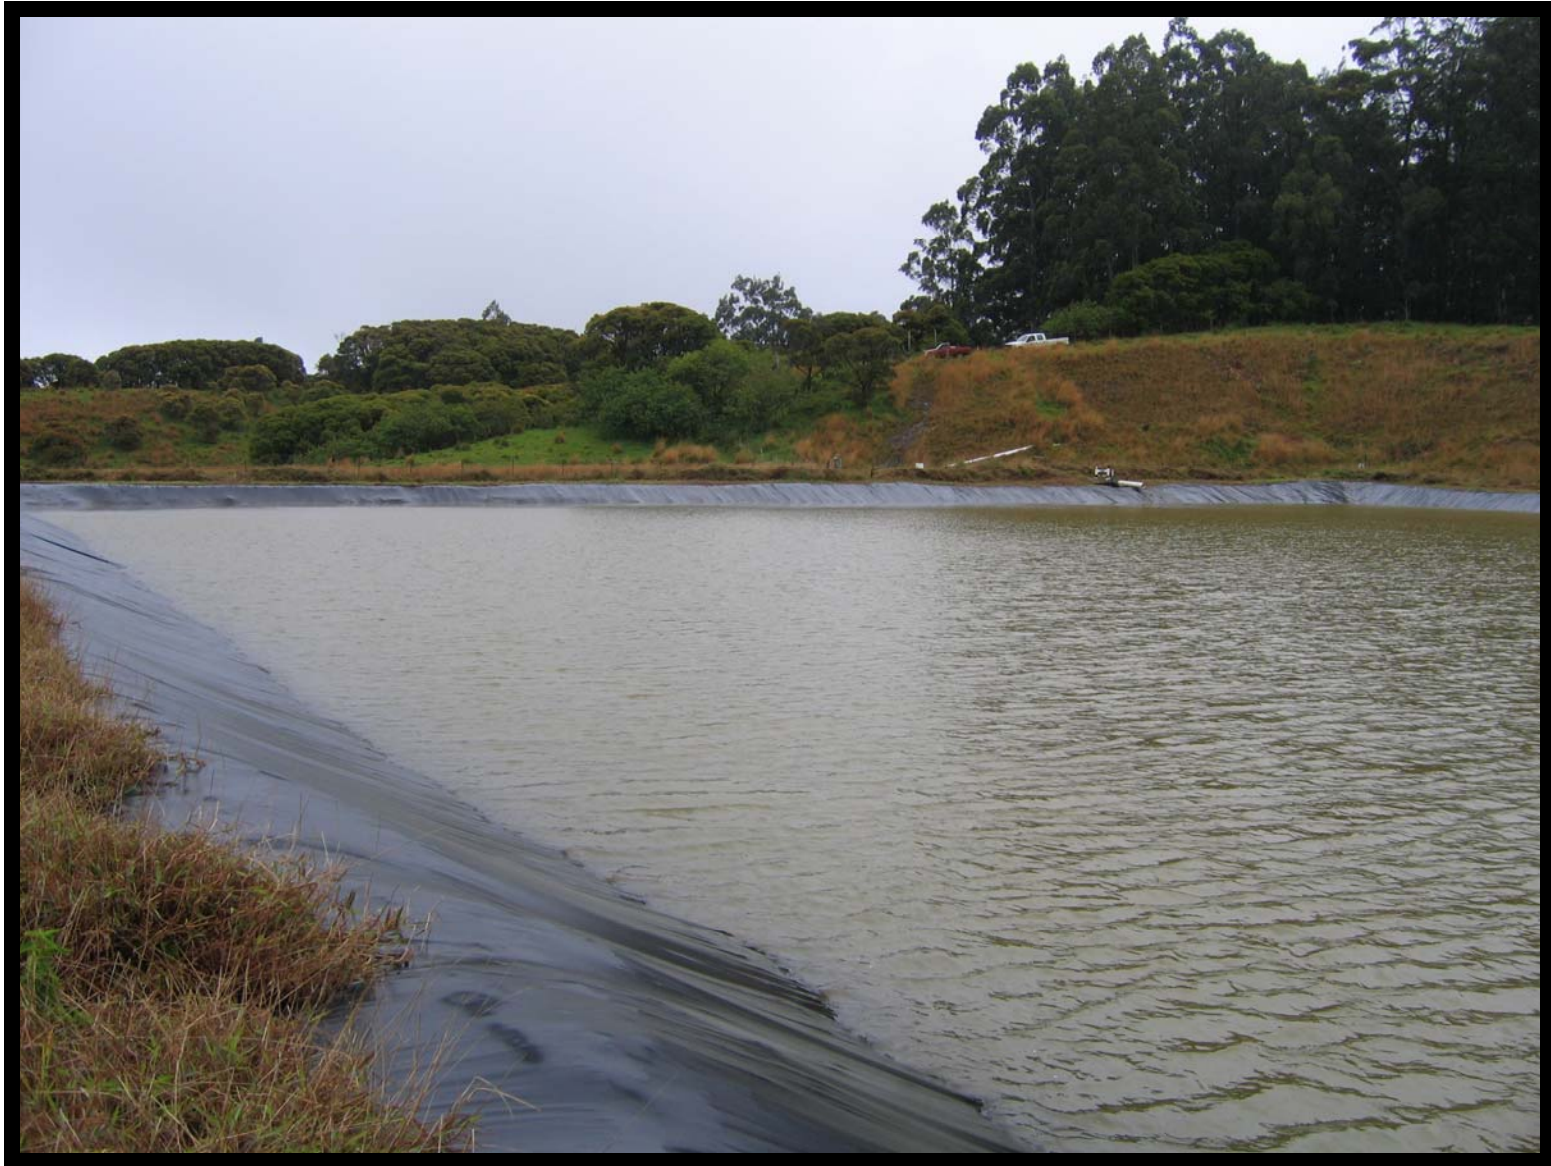
143 Reservoir and view of the rear upper slope

The reservoir level during the inspection was about 3 feet below the spillway. No staff gage was located at the site. According to staff personnel, the reservoir is normally operated at about 3 ft below the spillway except during drought conditions. No Sinkholes or depressions were observed.

- a. The reservoir appeared to be in fair to poor condition and requires corrective action.
- b. A staff gage was not observed at the reservoir. Provide some method of quantifying the water level within the reservoir.

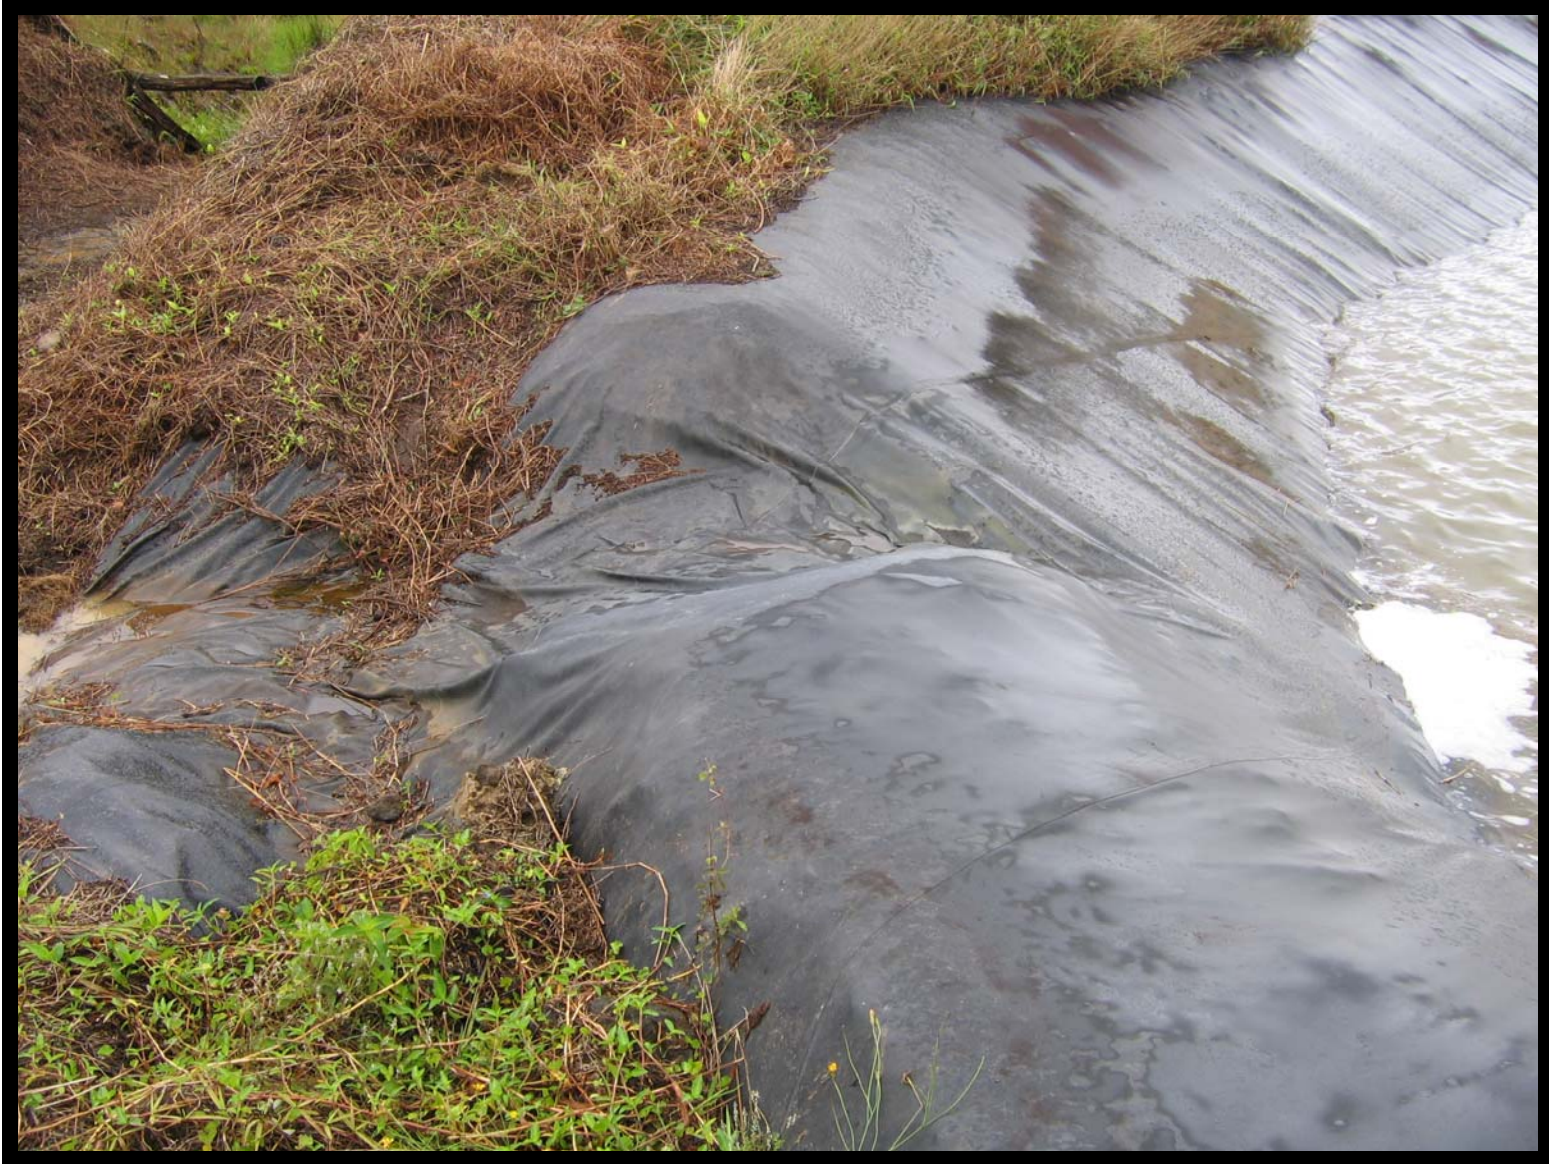
143 Spillway

This spillway consisted of an uncontrolled (5ft wide by 2ft deep) channel that began with a HDPE liner and transitioned into native ground near the left downstream end of the dam. The spillway channel then feeds a drainage ditch that runs along the left downstream edge of the downstream toe. The spillway approach was clear. There was no erosion observed near the spillway. The downstream vegetation appears to be primarily grass pasture.

- a. The Spillway appeared to be in satisfactory condition, no corrective actions are required at this time.

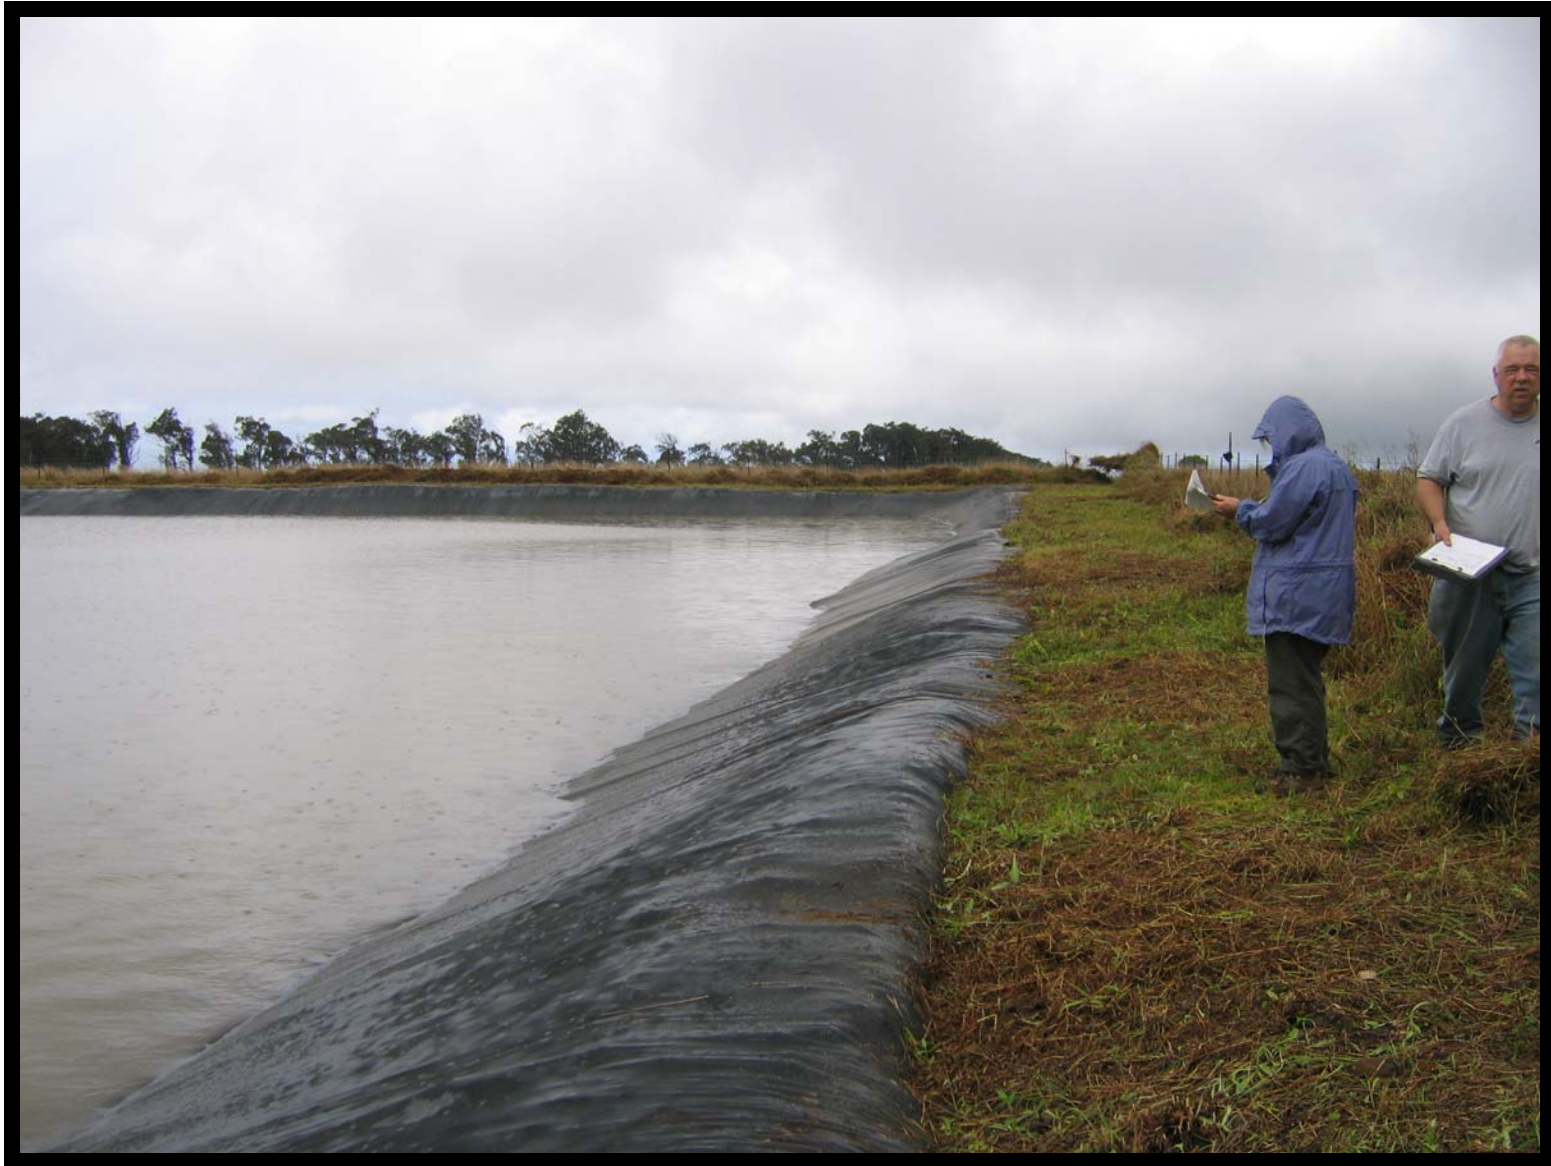
143 Upstream

The upstream slope varied in slope and ranged from a 2H to 1V. Slope protection consisted of the HDPE liner. Erosion were not observed, the slope was entirely visible. Cracks were not observed, the slope was entirely visible. Sinkholes were not observed, the slope was entirely visible.

- a. The upstream slope appeared to be in satisfactory condition, no corrective actions are required at this time.
